Appendix B

Photographs

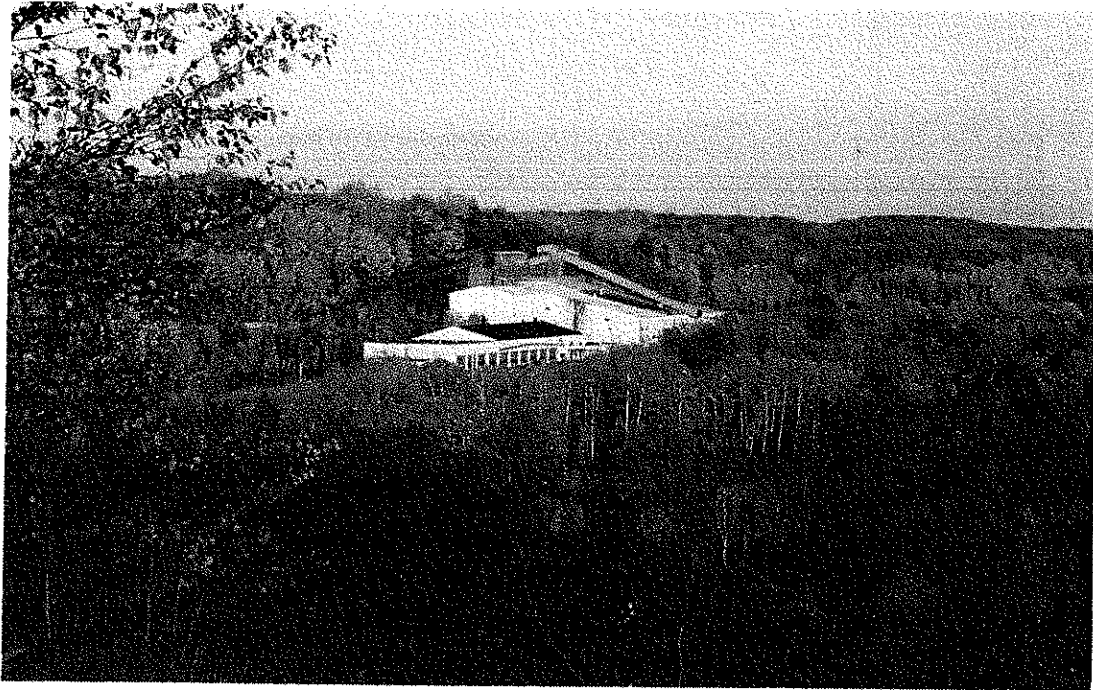
Photograph 1 – September 2006 by Jeff Lynott

Description: Overview of Humboldt Mill site looking east. Mill office is lower building in foreground; mill is larger building in background.

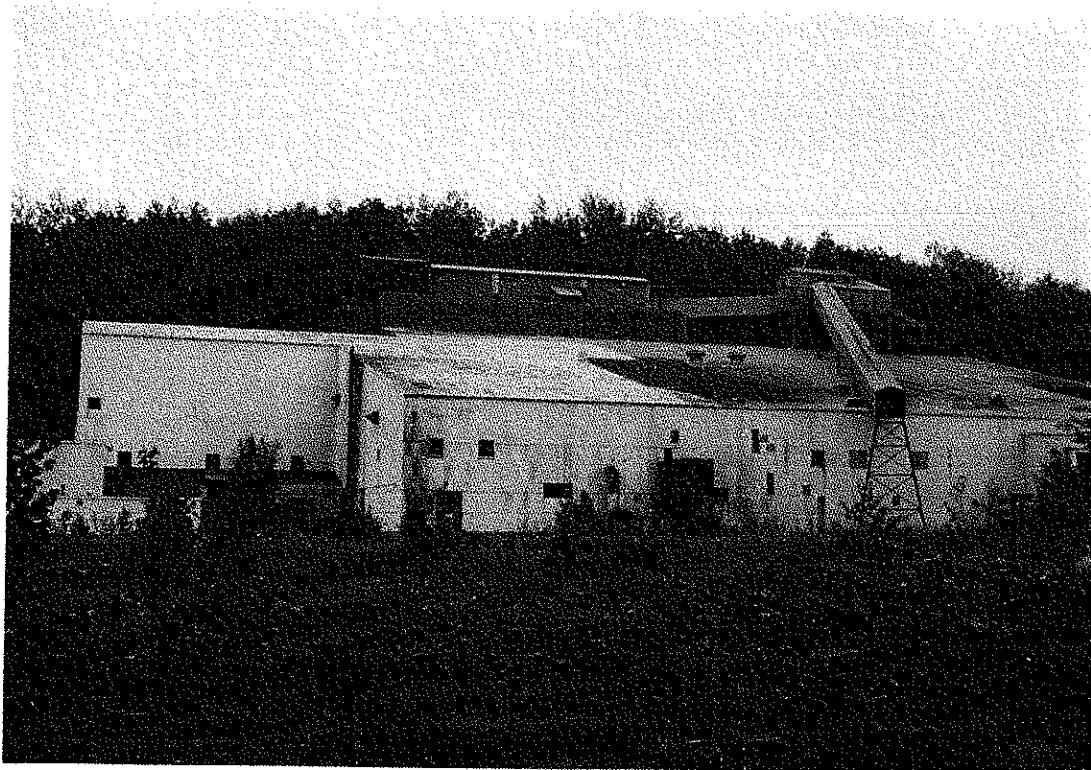
Photograph 2 – June 2006 by Curtis Dungey

Description: Mill building looking north.

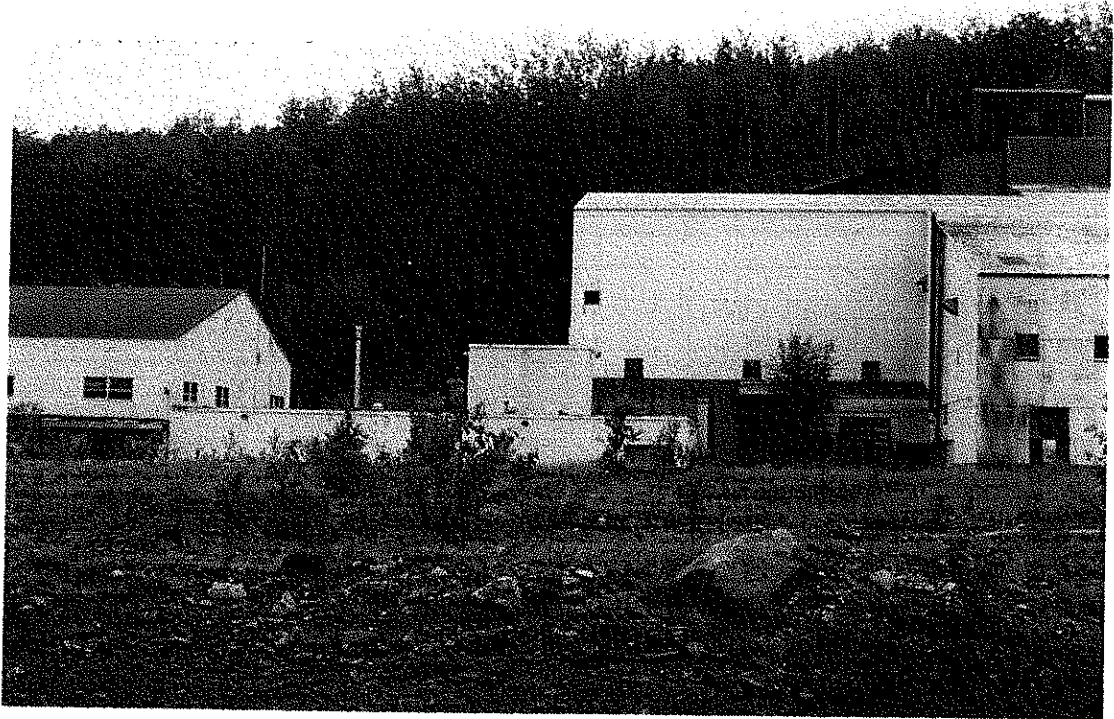
Photograph 3 – June 2006 by Curtis Dungey

Description: West end of mill building, with conveyor gallery in background.

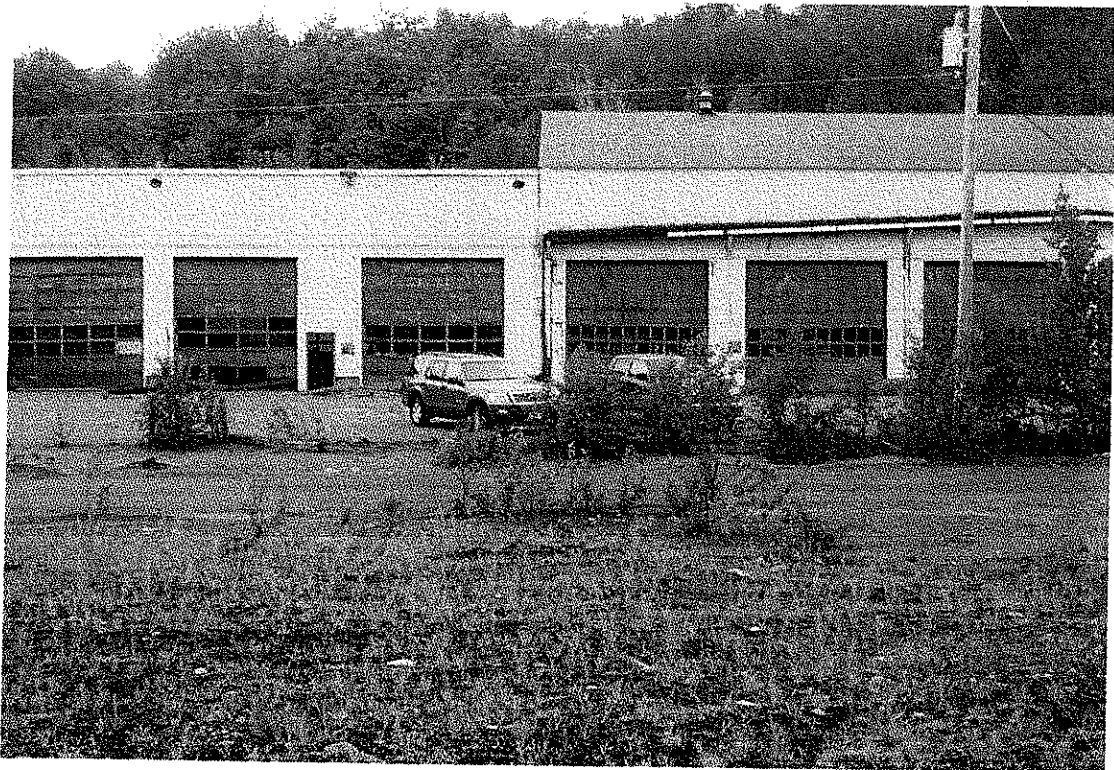
Photograph 4 – June 2006 by Curtis Dungey

Description: Shop building to west of mill.

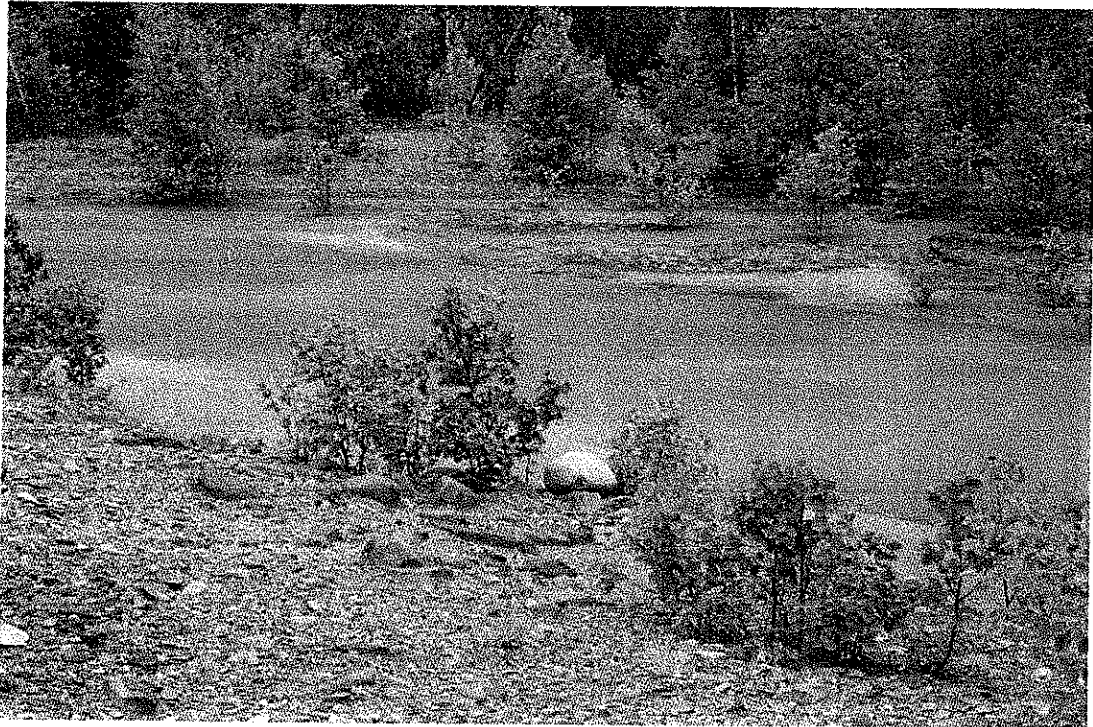
Photograph 5 – June 2006 by Curtis Dungey

Description: Stained pavement and stressed vegetation below pyrite trench at entrance to facility.

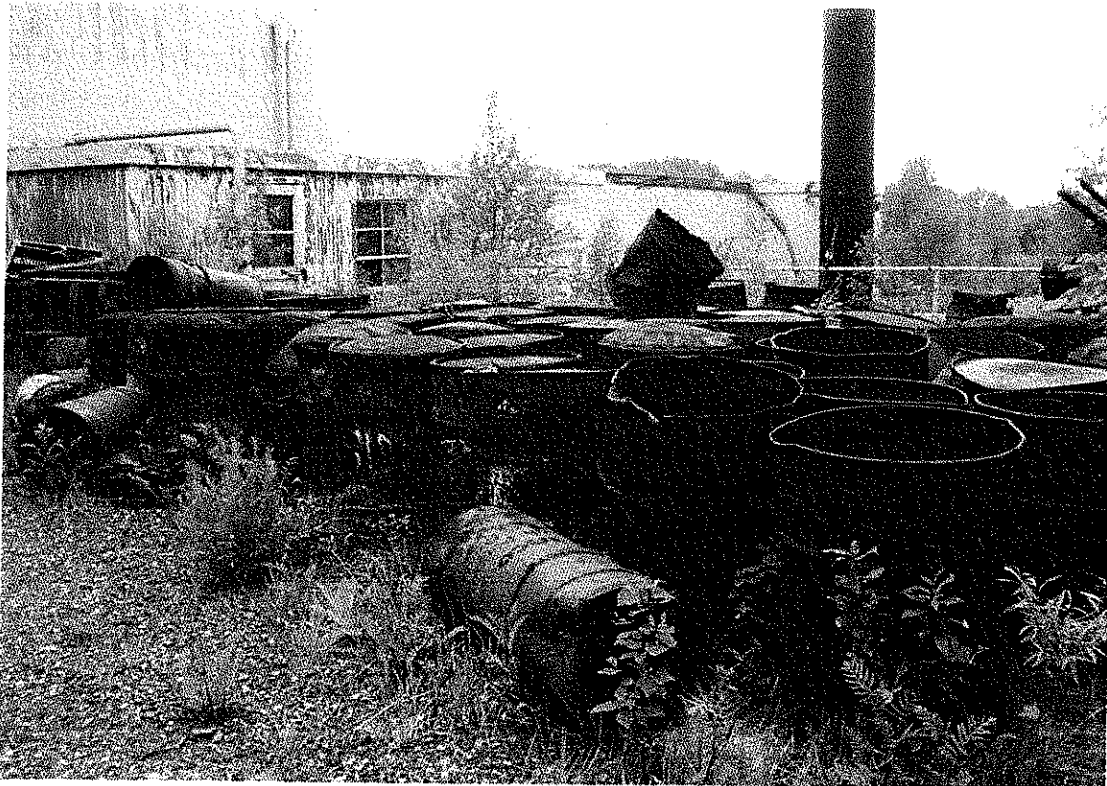
Photograph 6 – June 2006 by Curtis Dungey

Description: Empty steel drums at west end of mill (first observed in 2006; these have since been removed from site).

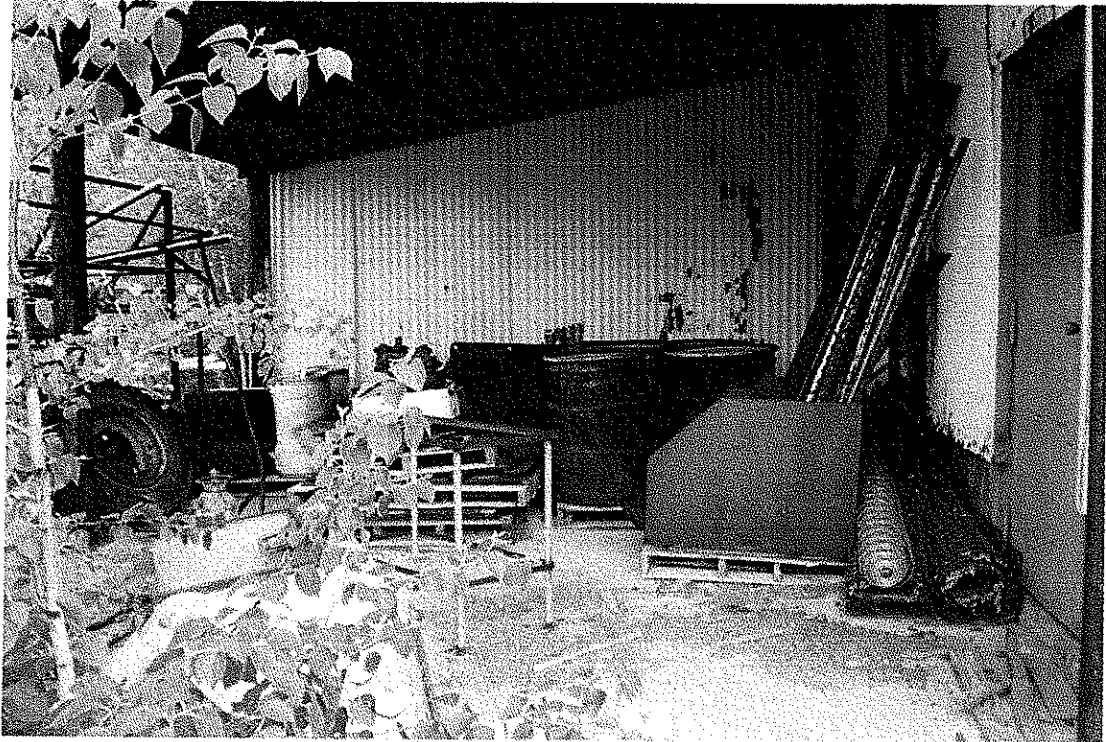
Photograph 7 – June 2006 by Curtis Dungey

Description: Drums and debris under cover adjacent mill building.

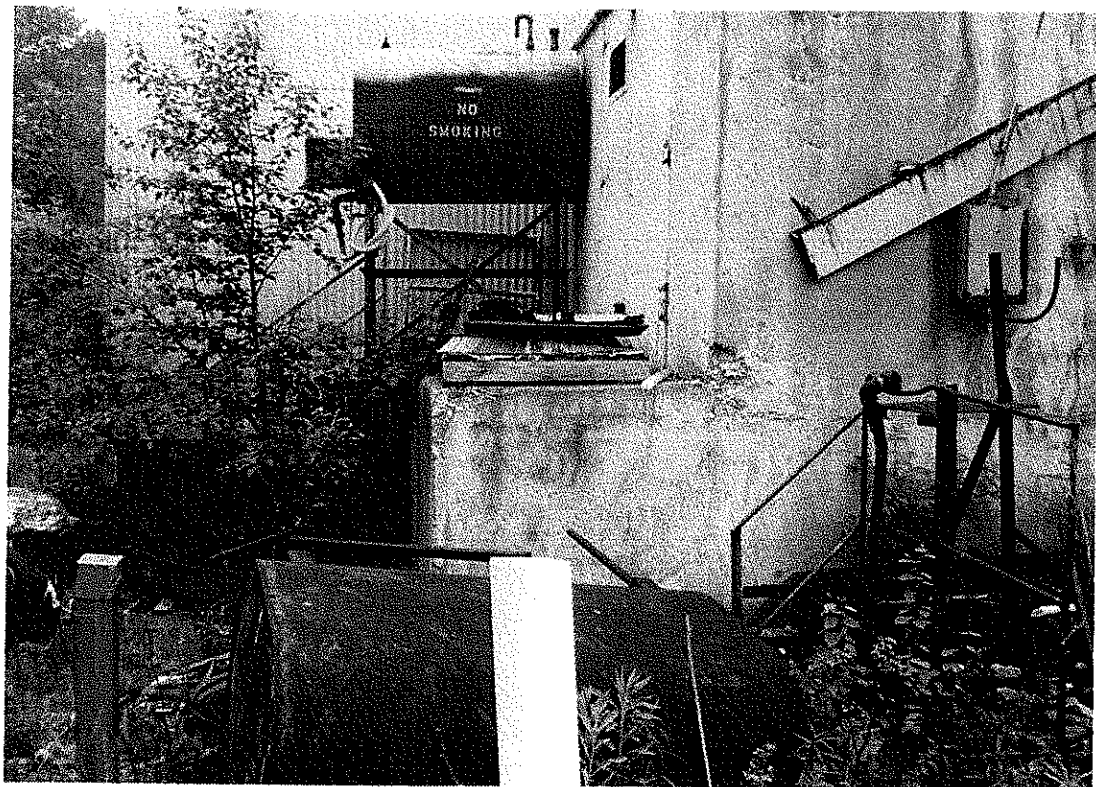
Photograph 8 – June 2006 by Curtis Dungey

Description: Two small ASTs located behind mill – GW monitoring well in foreground.

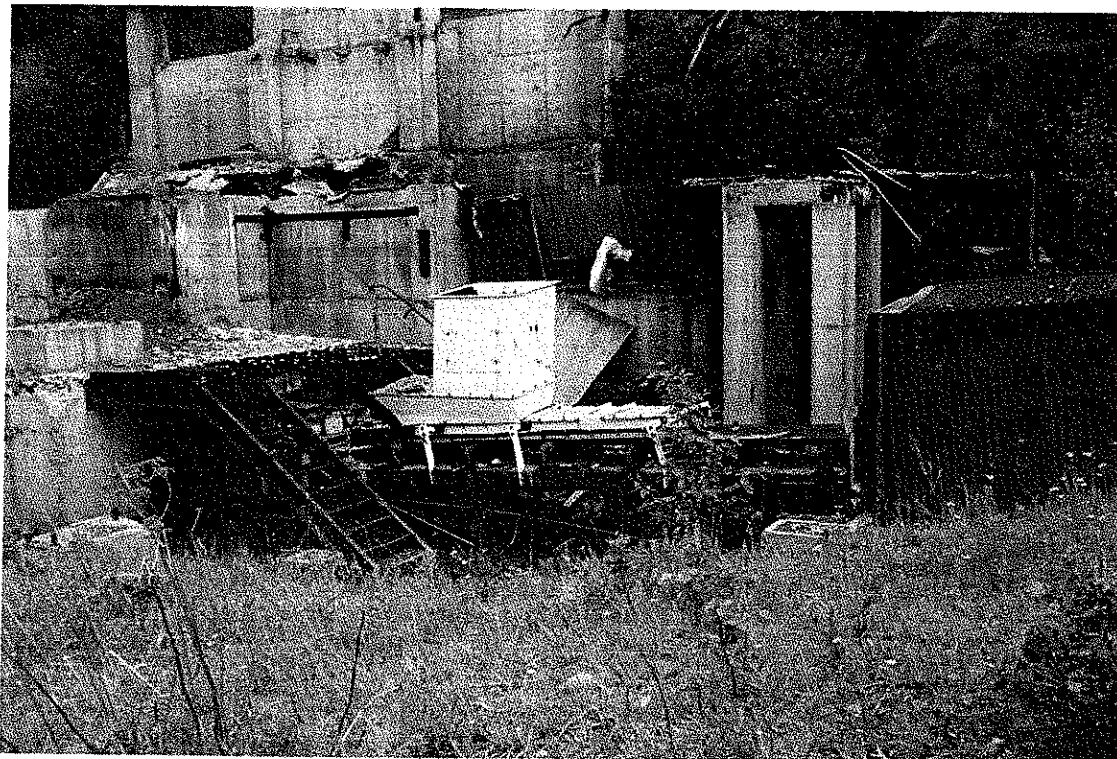
Photograph 9 – June 2006 by Curtis Dungey

Description: Ruins of old secondary crusher with miscellaneous debris.

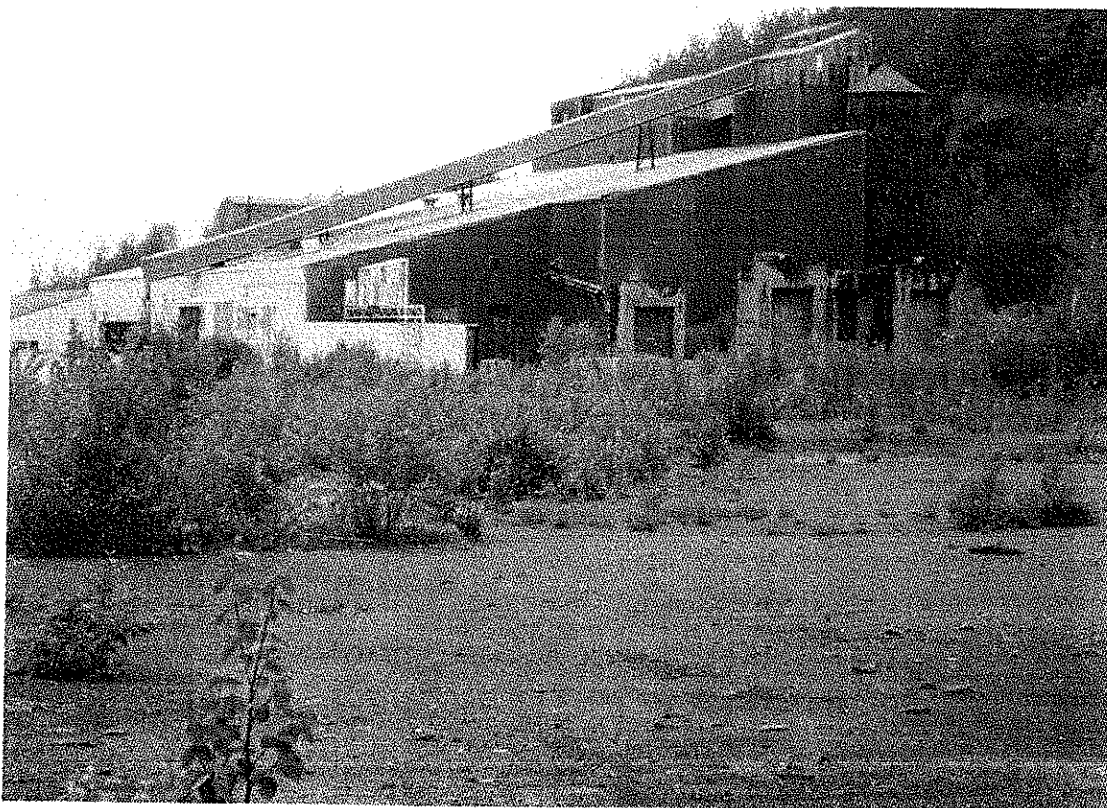
Photograph 10 – June 2006 by Curtis Dungey

Description: East end of mill building – thickener on SE corner with storage silo on NE corner.

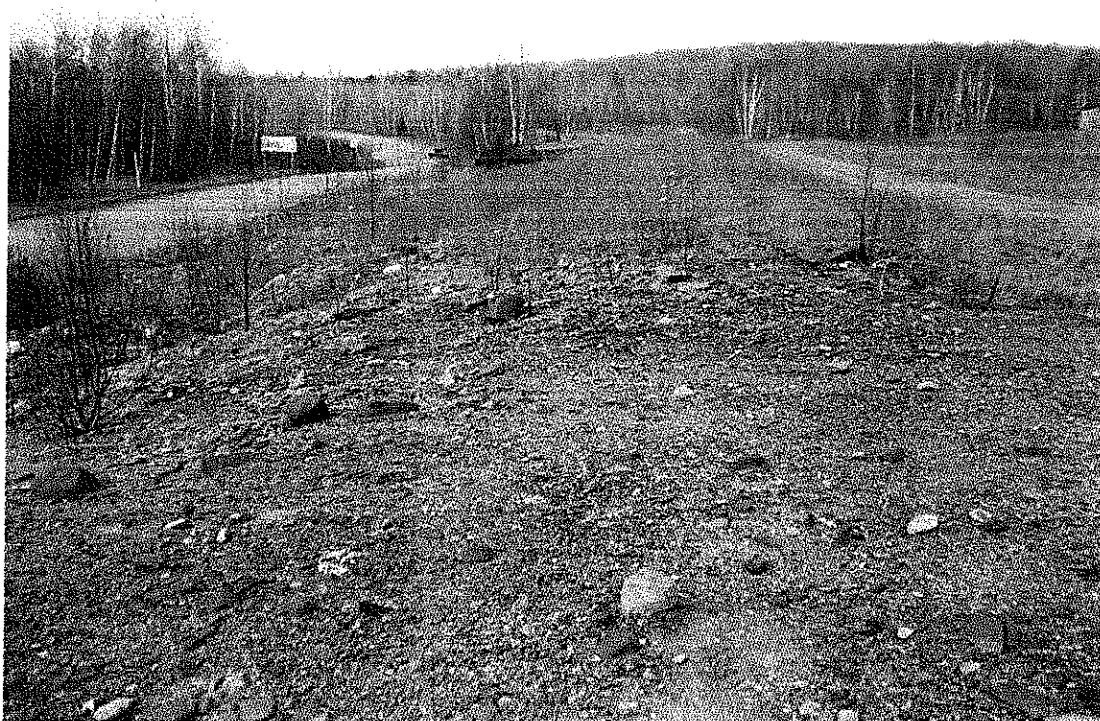
Photograph 11- September 2006 by Jeff Lynott

Description: Buried pyrite trench area, looking west towards mill property entrance.

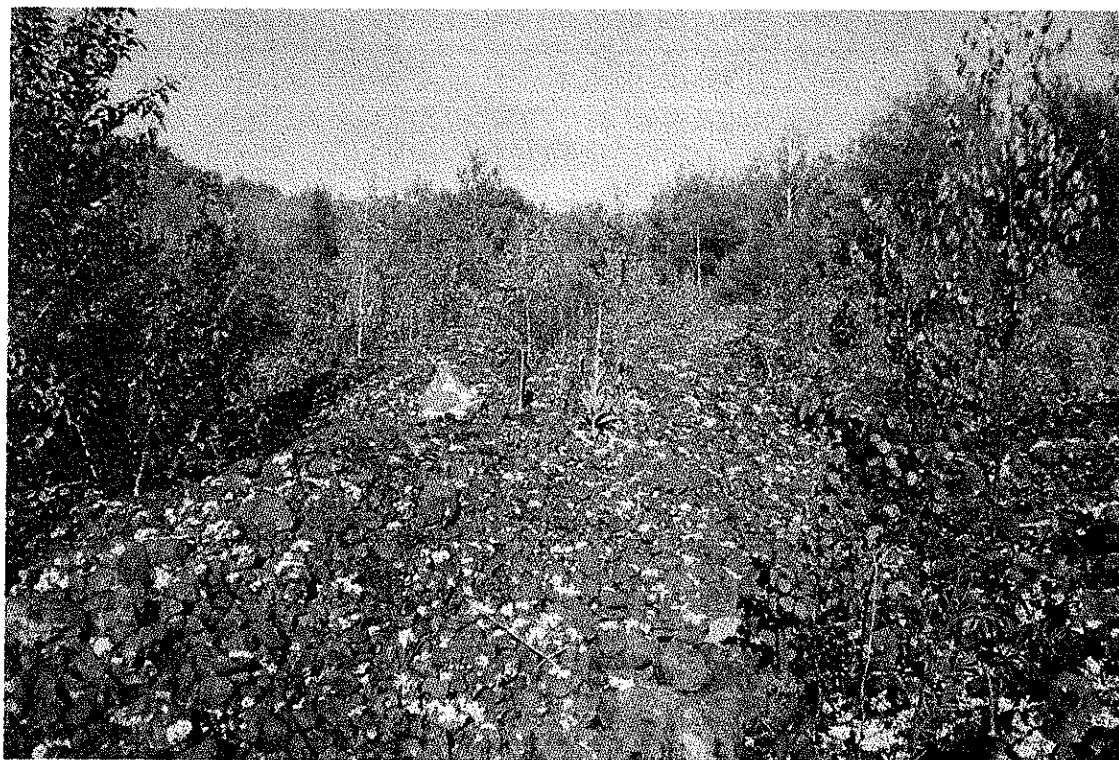
Photograph 12 – September 2006 by Jeff Lynott

Description: Iron concentrate scale stockpiles from pellet kiln. View looking northeast adjacent iron ore tailings storage facility.

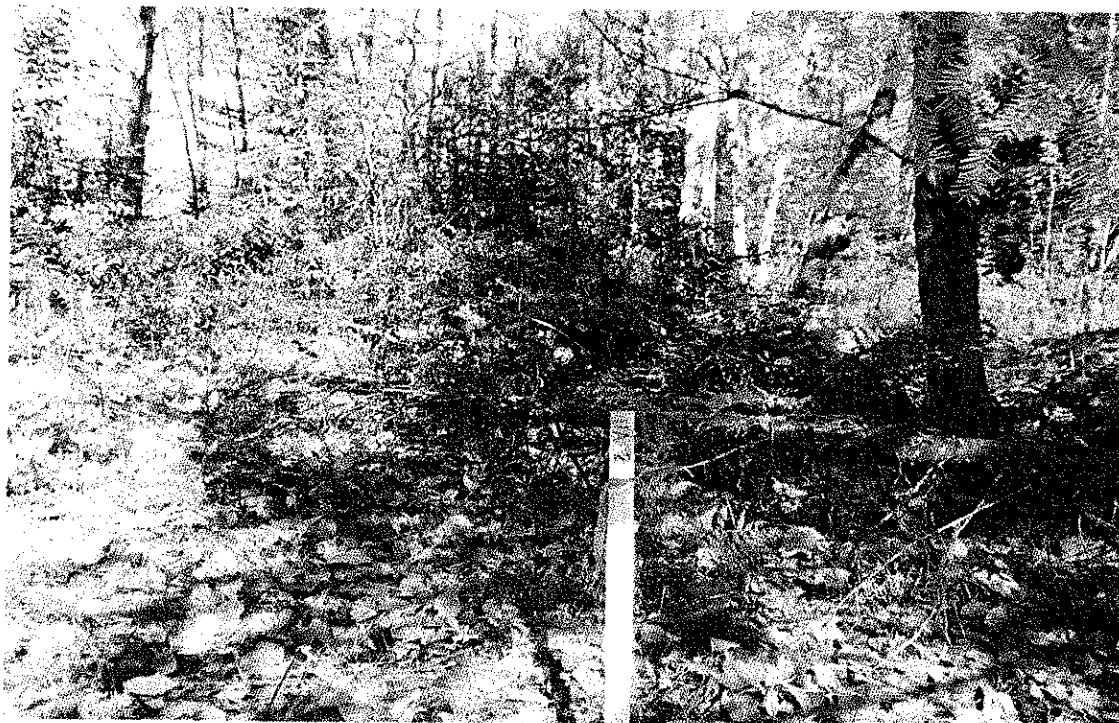
Photograph 13 – September 2006 by Jeff Lynott

Description: Discharge pipe (“stormwater outfall”) located below red-handled hammer and adjacent septic system to south of mill.

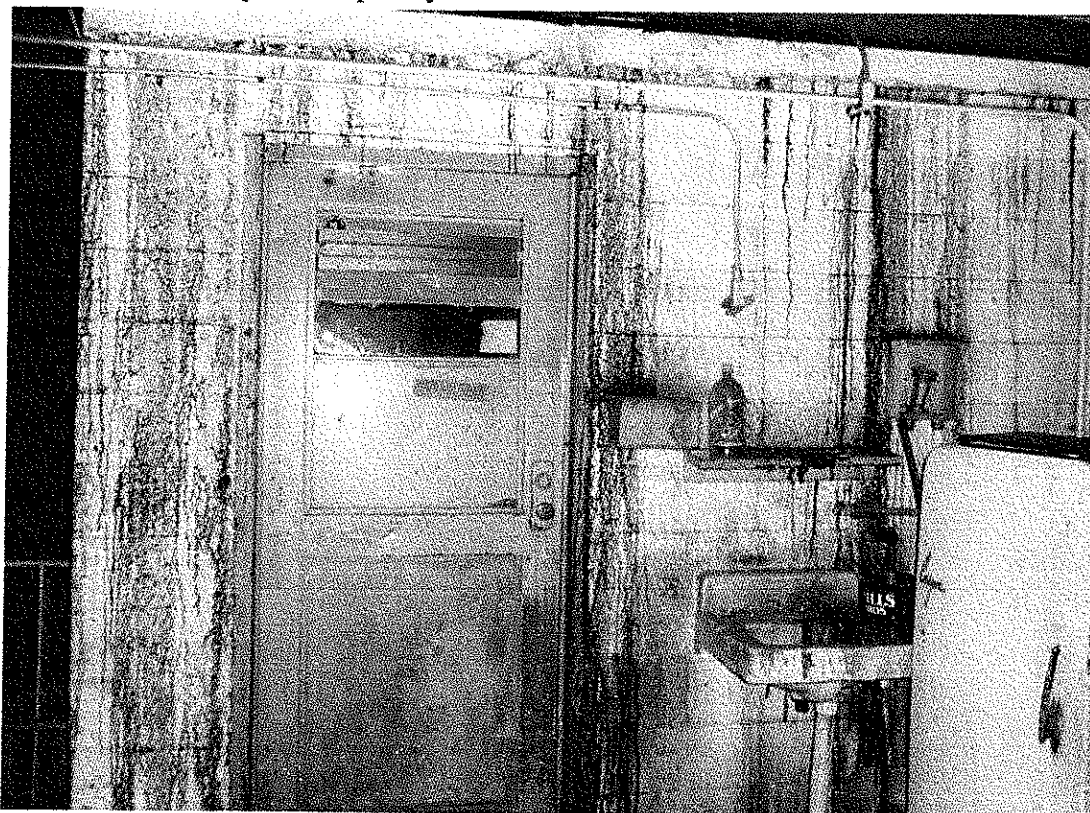
Photograph 14 – September 2006 by Jeff Lynott

Description: Tar-like substance located on outside wall of office structure inside mill building.

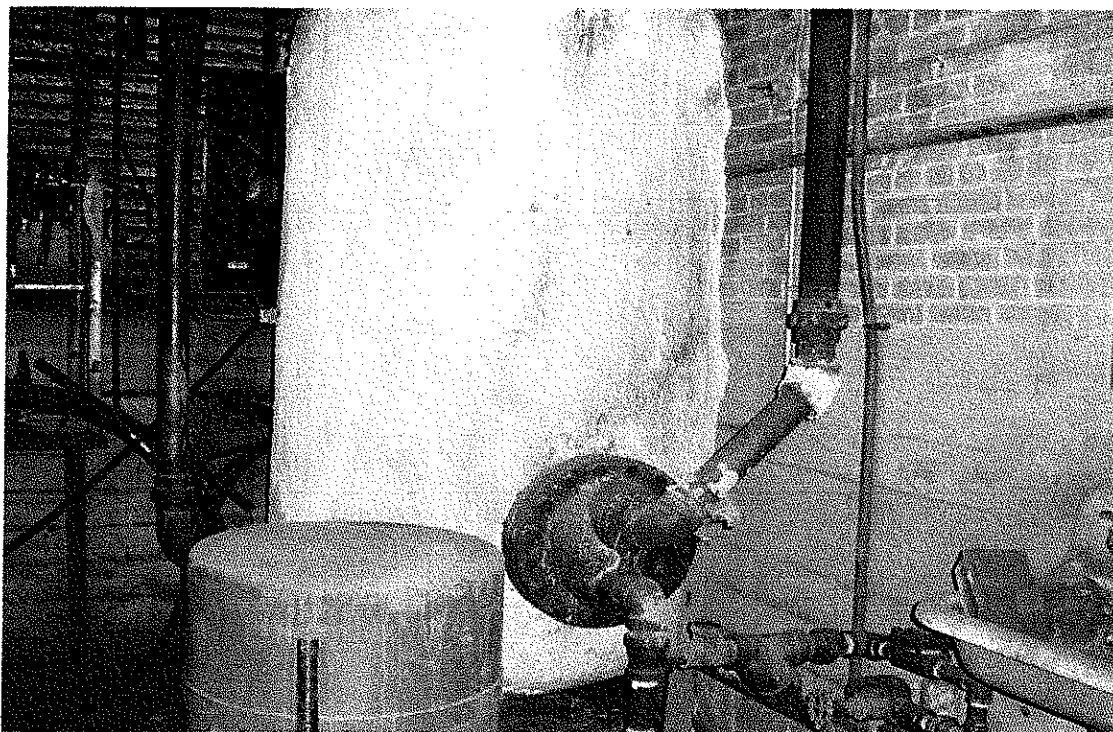
Photograph 15 – June 2006 by Curtis Dungey

Description: Asbestos covering an air receiver inside boiler room area.

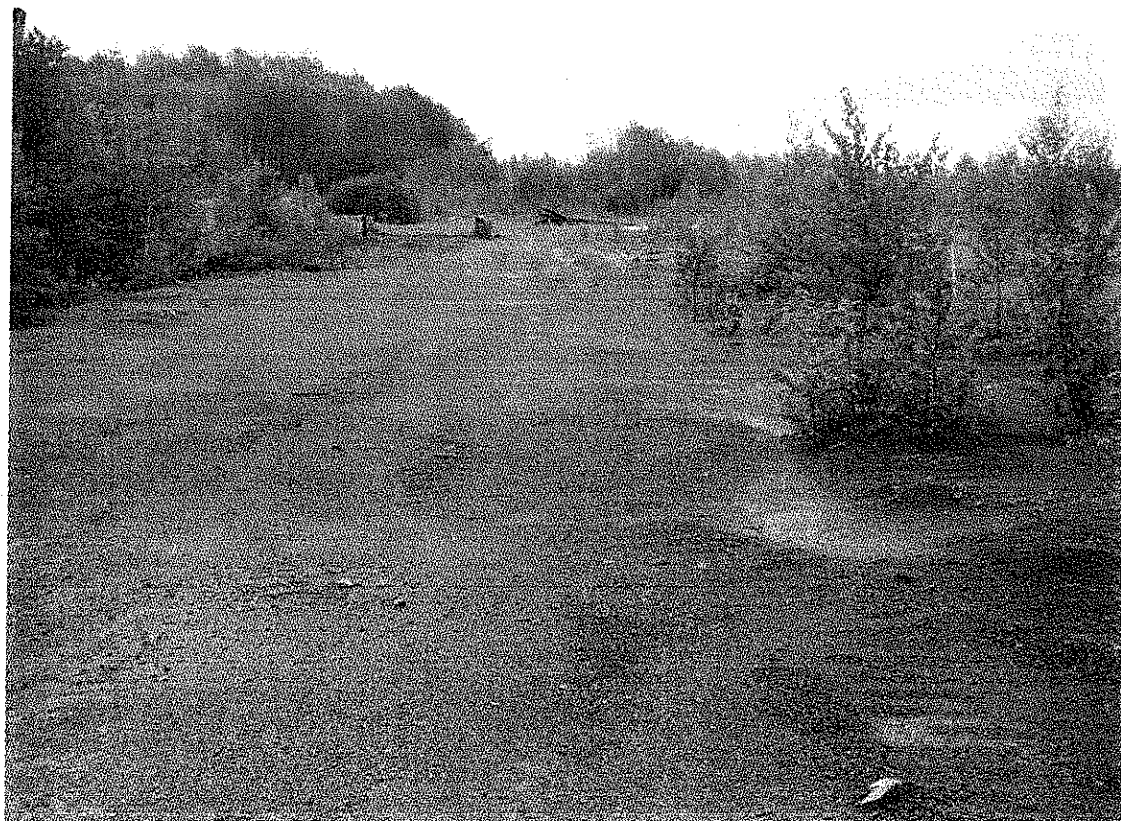
Photograph 16 – June 2006 by Curtis Dungey

Description: View looking east across former stockpile area south of the mill.
Note iron pellets on surface.

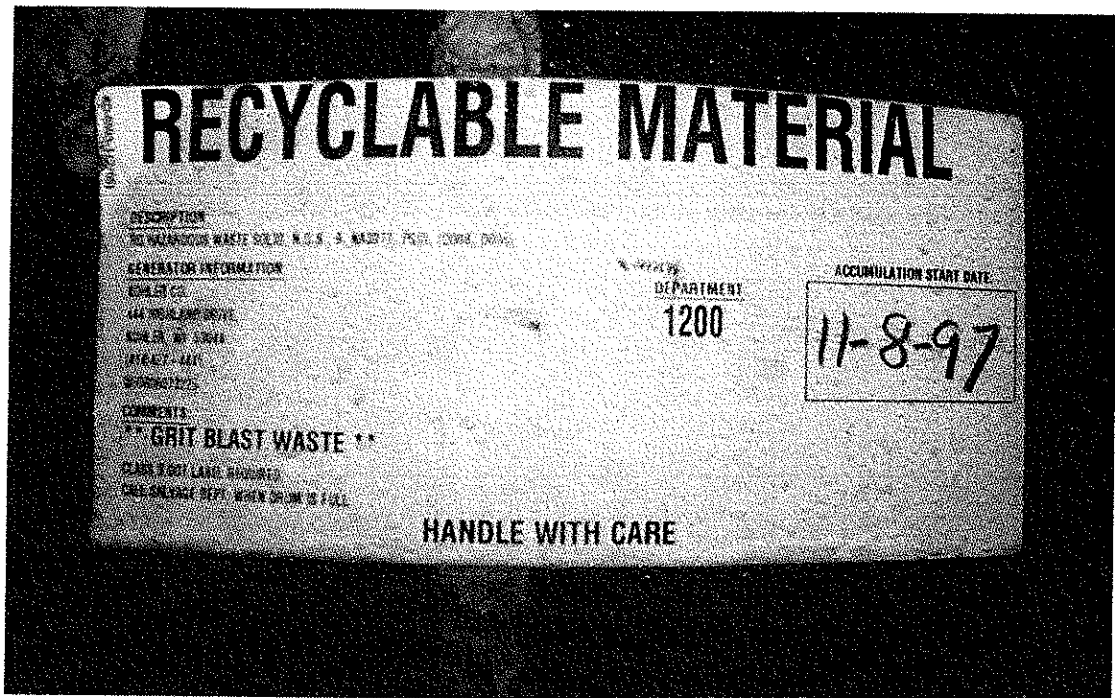
Photograph 17 – March 2006 by Scott Janssen

Description: Label on sealed drum, suggesting material may be hazardous waste.

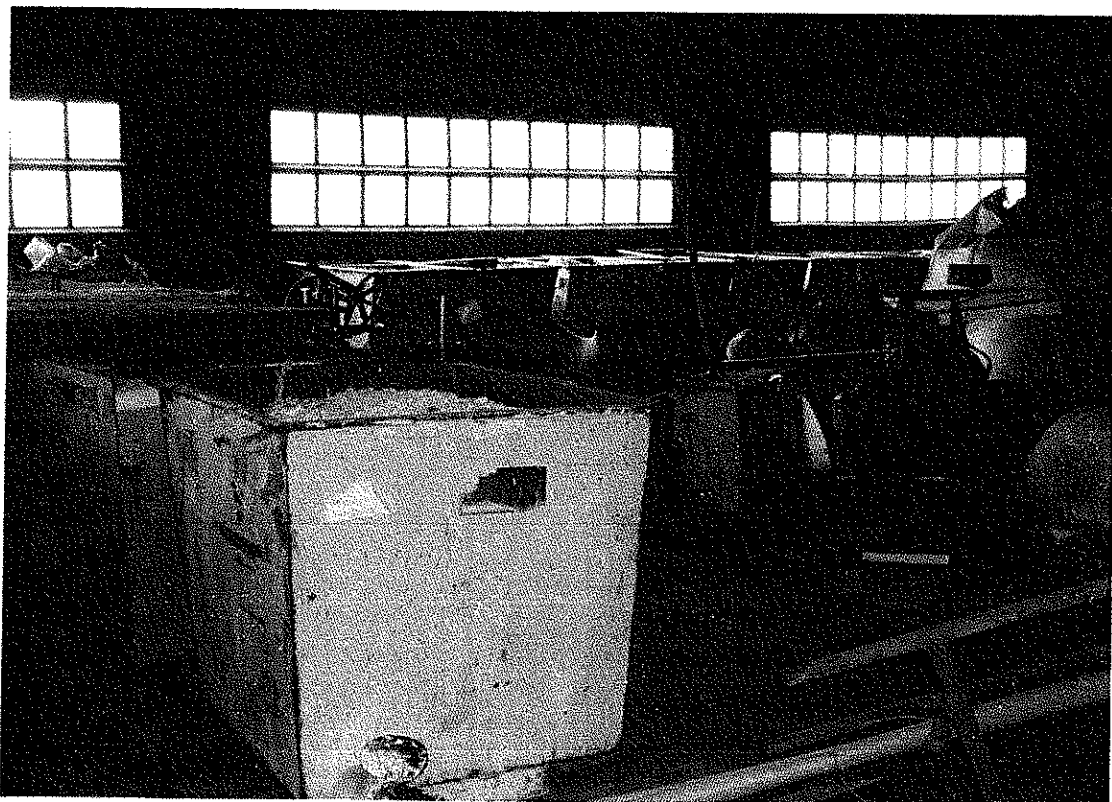
Photograph 18 – March 2006 by Scott Janssen

Description: Open bins and supersacks of materials stored in maintenance shop.

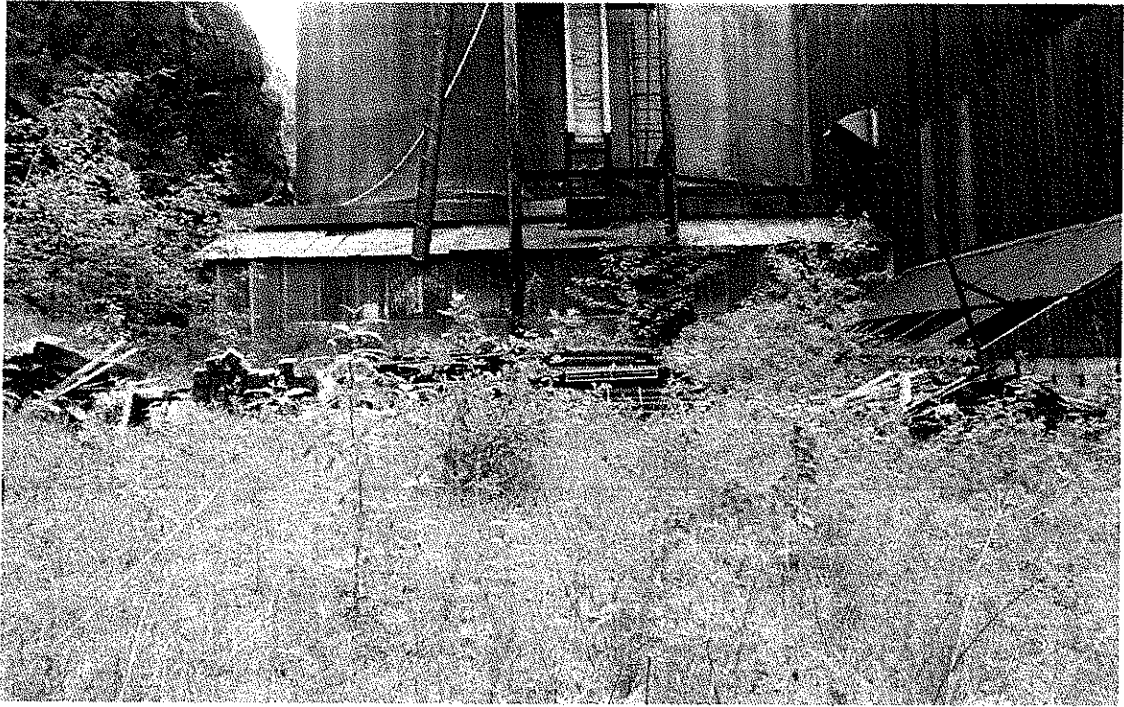
Photograph 19 – June 2006 by Curtis Dungey

Description: Miscellaneous debris stored to north of mill building.

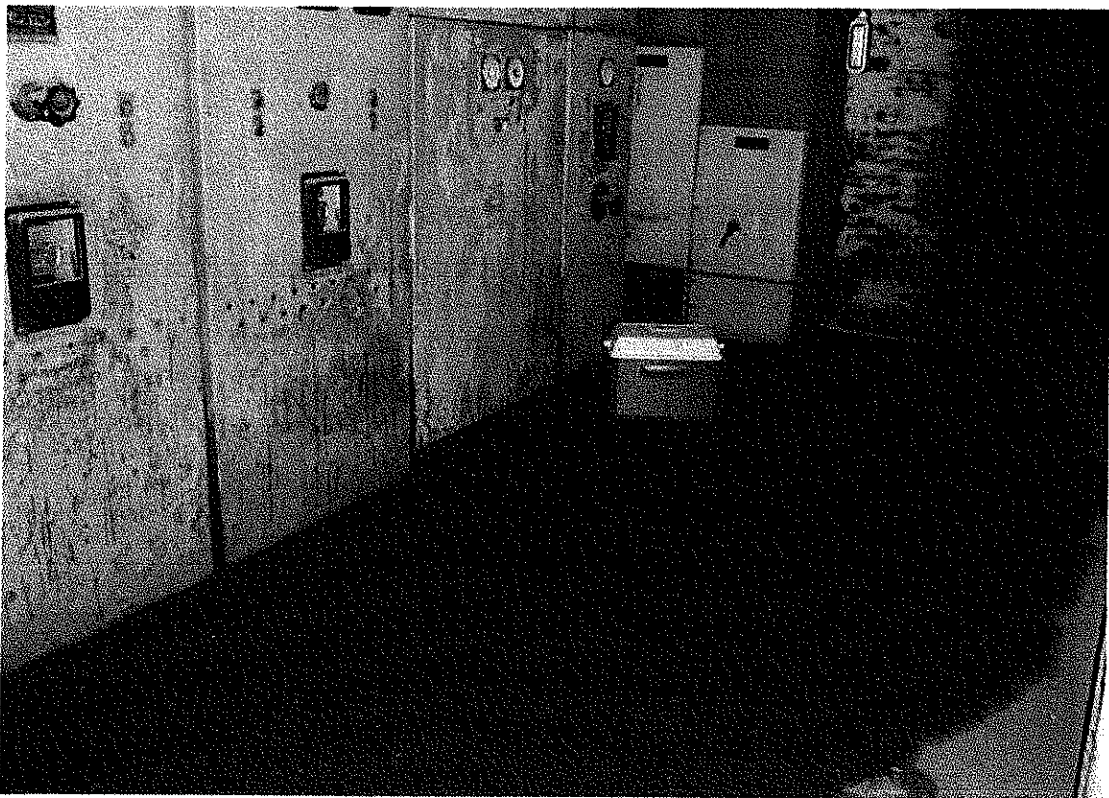
Photograph 20 – September 2006 by Jeff Lynott

Description: Dark staining on motor control center floor inside mill building.

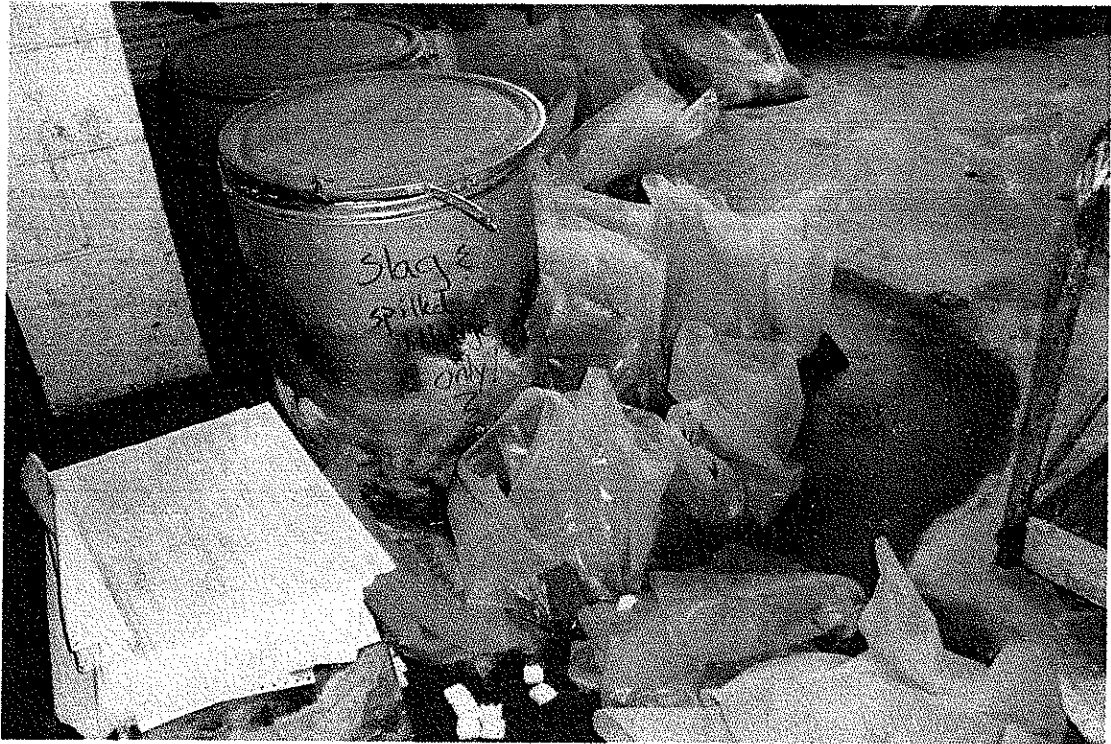
Photograph 21 – March 2006 by Scott Janssen

Description: Staining on floor of old lunchroom area from storage of fire assay waste.

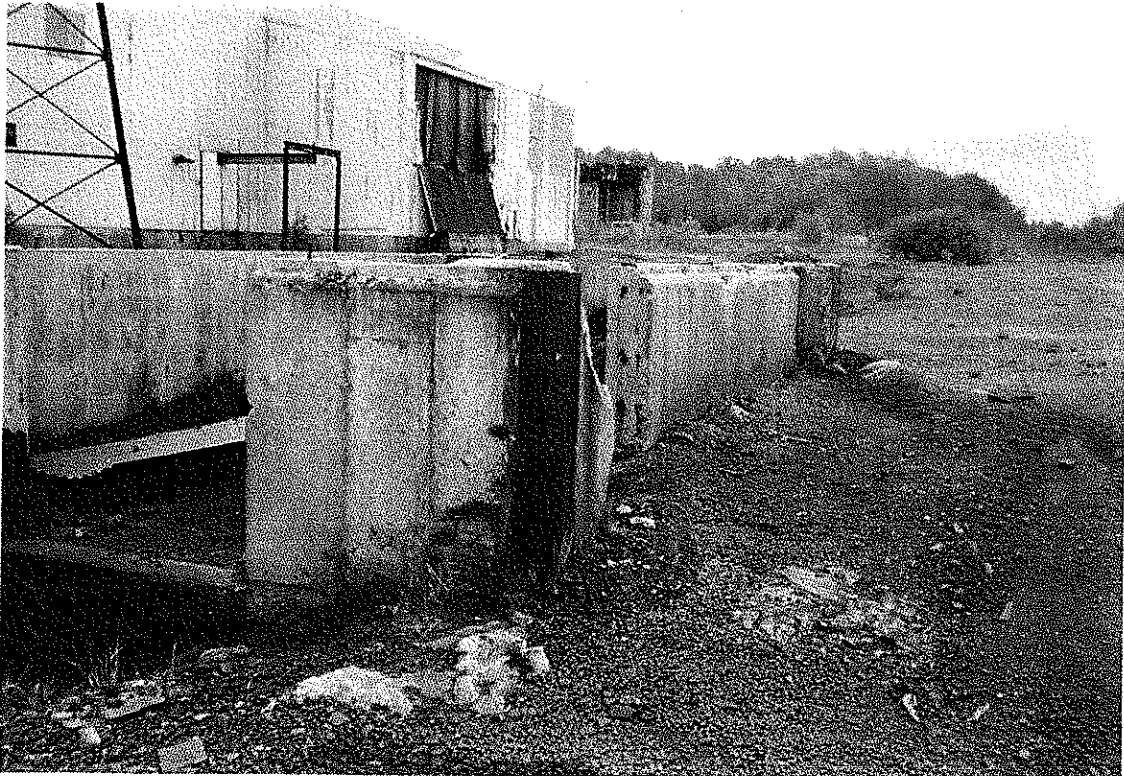
Photograph 22 – June 2006 by Curtis Dungey

Description: Ruins of former railroad loadout area south of mill. Dark staining inside structure.

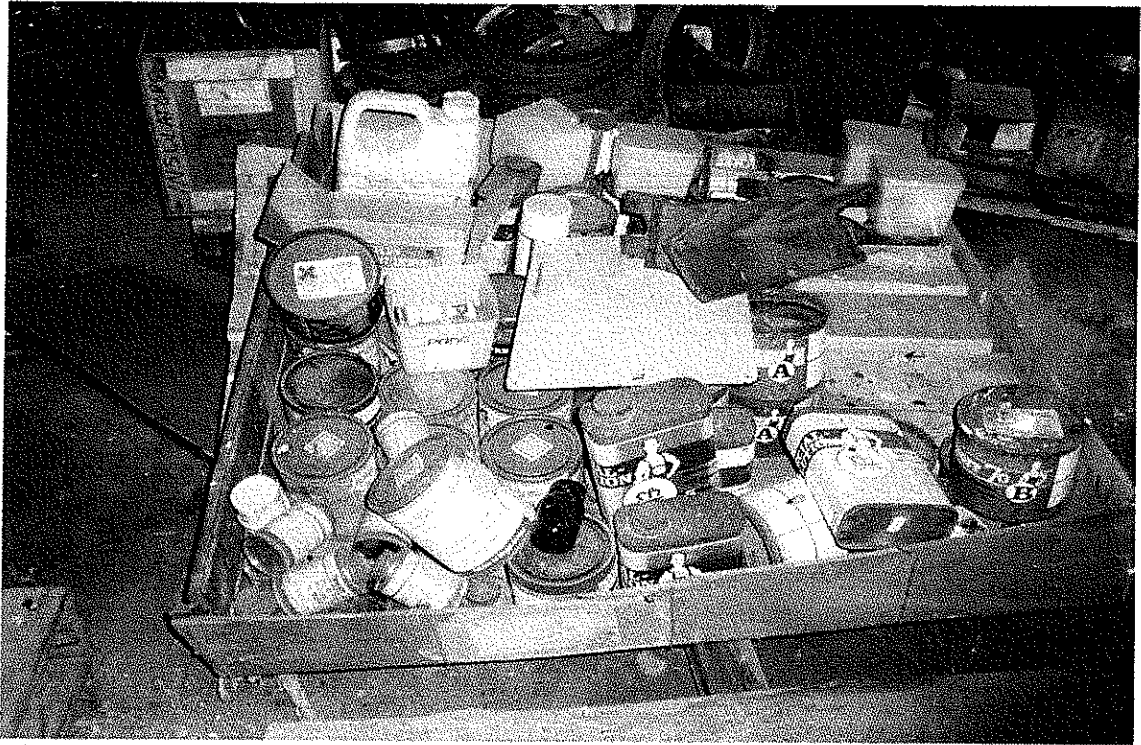
Photograph 23 – June 2006 by Curtis Dungey

Description: Remaining paints and chemicals stored in west end of shop area.

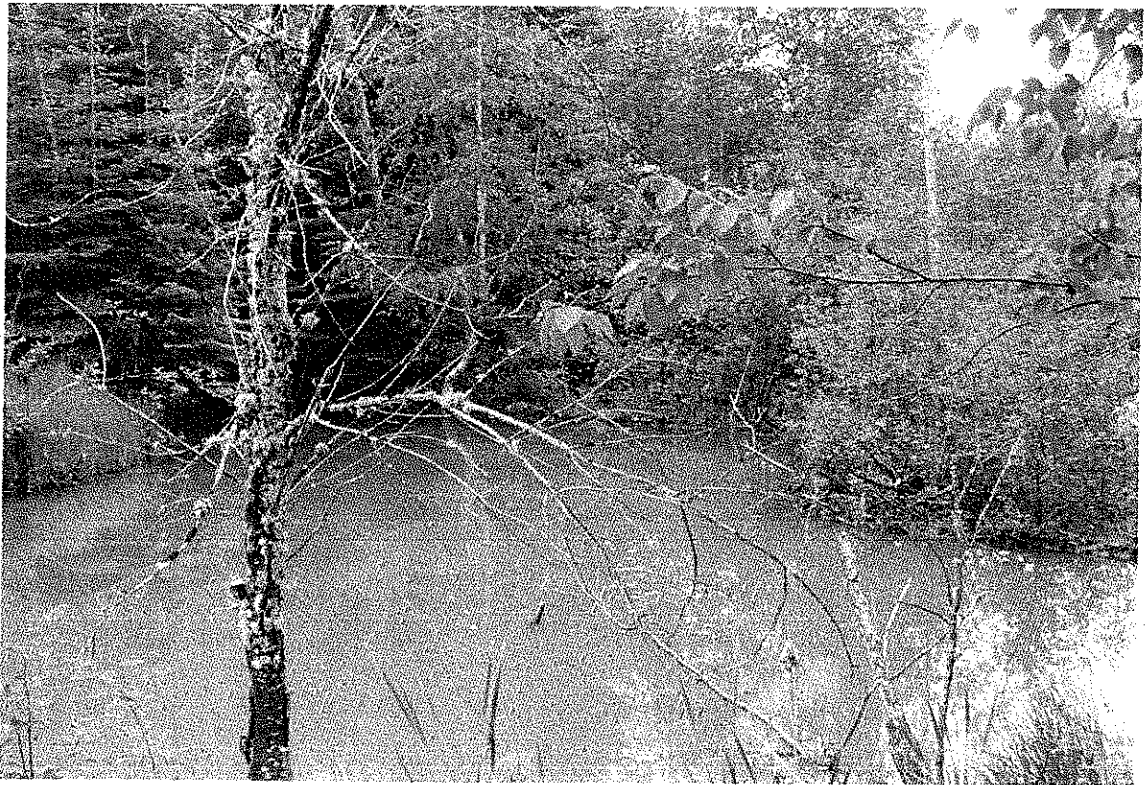
Photograph 24 – June 2006 by Curtis Dungey

Description: Pond located south of mill with constructed dam.

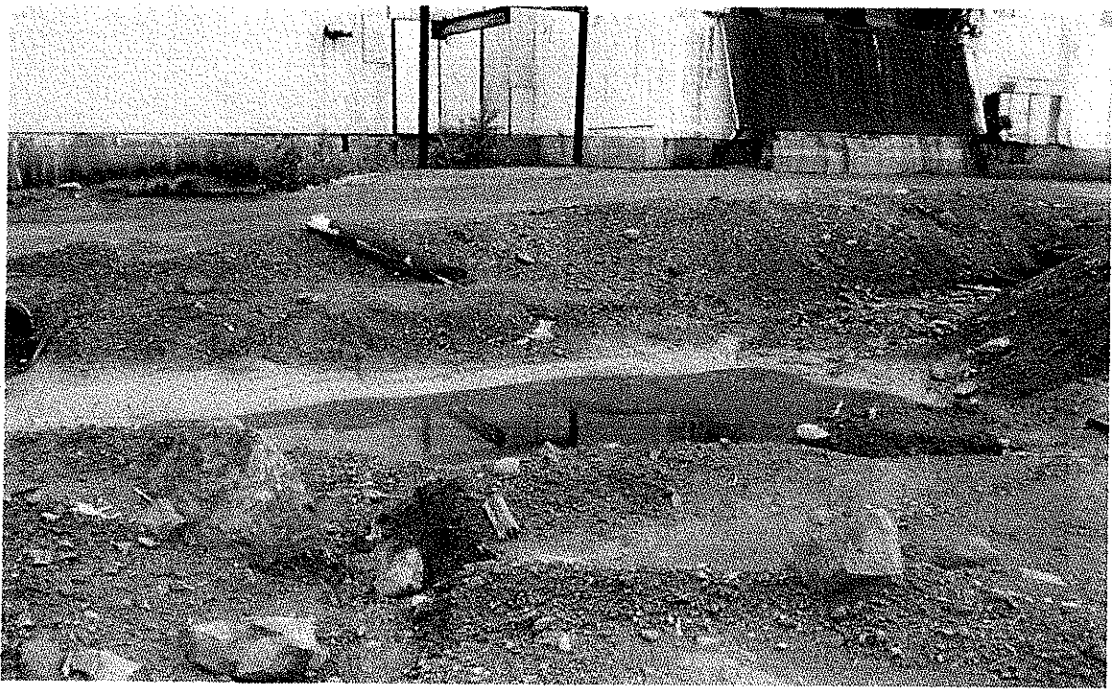
Photograph 25 – June 2006 by Curtis Dungey

Description: Standing water in ditch located south of mill, running east and west.

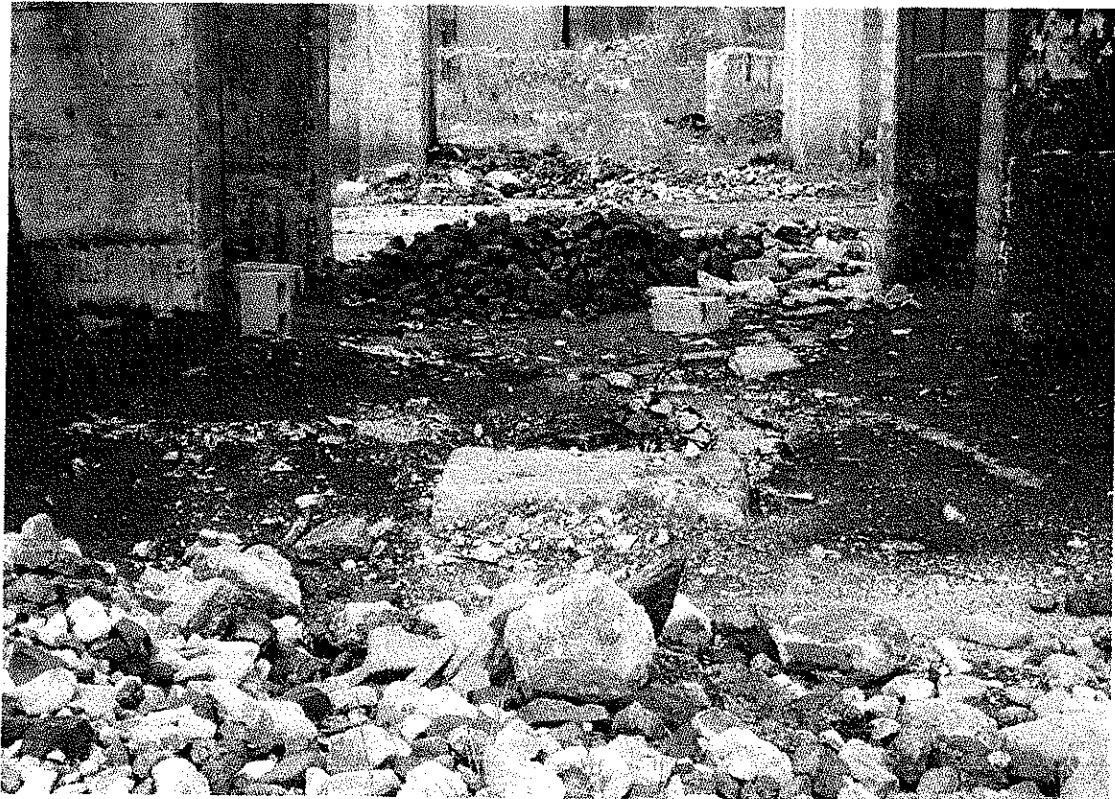
Photograph 26 – June 2006 by Curtis Dungey

Description: Remaining process debris from former pellet plant operation.
